# Evaluation Report

# 696

## Case IH 8500 Air Hoe Drill

## CASE IH 8500 AIR HOE DRILL

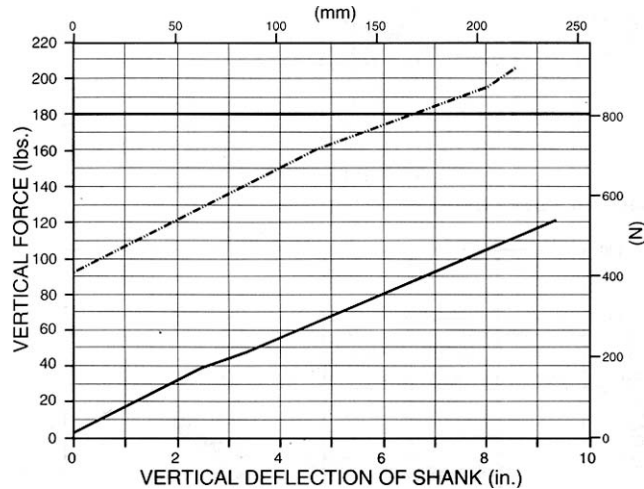
The spring force was varied by changing the length of the spring. The depth of the hoe opener was also adjustable. Twelve spring positions were possible for the hoe opener. FIGURE 3 illustrates the minimum and maximum vertical force deflection curves.

FIGURE 3. Minimum and maximum vertical force deflection curves for the hoe opener.

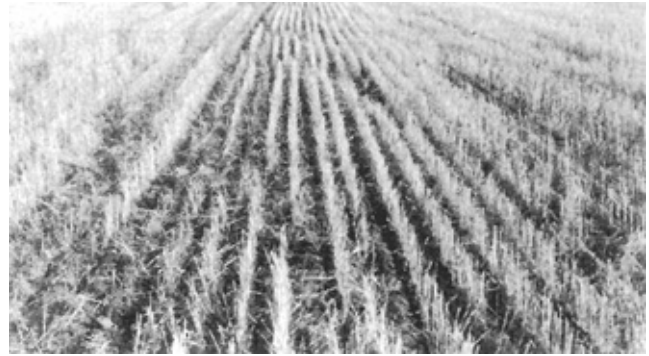
**Soil Finishing:** Soil finishing of the Case IH 8500 was very good. FIGURE 4 shows the soil surface after seeding into a previously tilled field. FIGURE 5 shows the soil surface after seeding into an untilled wheat stubble field. The majority of the stubble was left standing. Ridge depths left by the packer wheels ranged from 1.3 to 2.5 in (33 to 64 mm), depending on soil, operating speed and seed depth. The packing force was adequate for the soils and conditions encountered during the test.

FIGURE 5. Soil surface after seeding into an untilled Wheat stubble field.

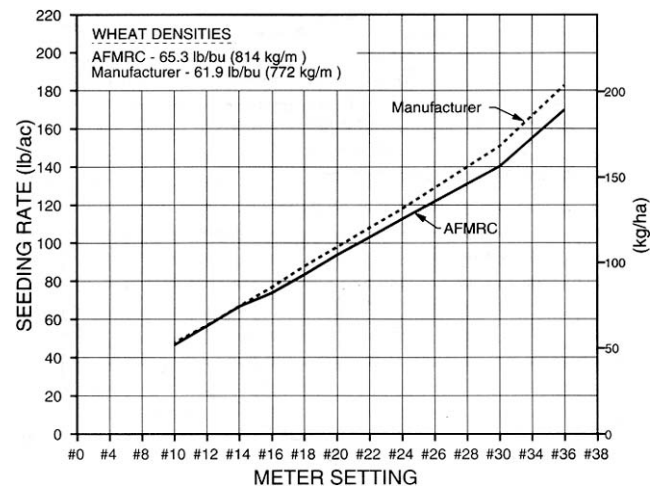
**Metering Accuracy:** Metering accuracy of the Case IH 8500 was good. The seed metering rate was varied by lateral movement of the feed rolls, the shaft speed and the position of the metering gate. The fertilizer metering rate was varied by the gate opening above the star shaped wheels and the shaft speed. The calibration curves obtained by AFMRC and the manufacturer with wheat, barley, peas, canola and 11-51-0 fertilizer are given in FIGURES 6 to 10. Any difference between the calibration curves obtained by AFMRC and the manufacturer are probably due to different seed size, density and moisture content. The densities obtained by AFMRC and the manufacturer are indicated on the graphs.

FIGURE 6. Metering accuracy with wheat.

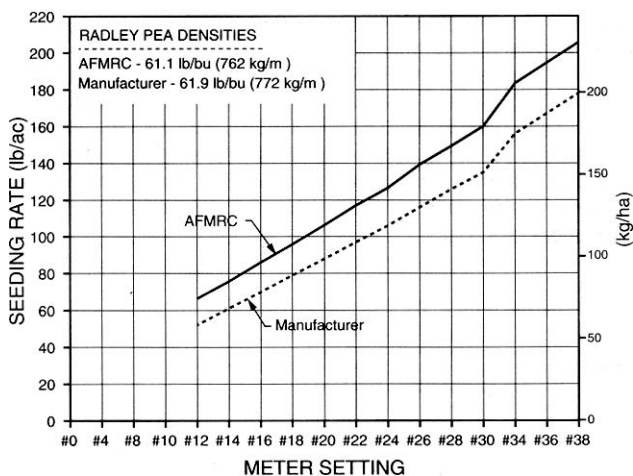
FIGURE 8. Metering accuracy with Radley peas.

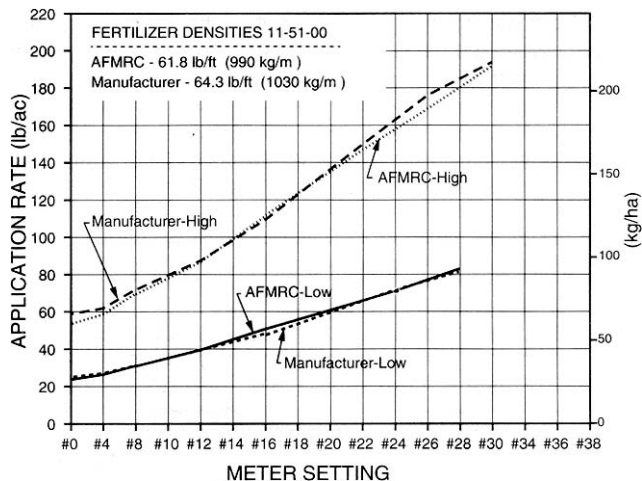
The maximum fertilizer rate for 11-51-0 fertilizer was 191 lb/ac (214 kg/ha).

FIGURE 10. Metering accuracy with 11-51-0 fertilizer.

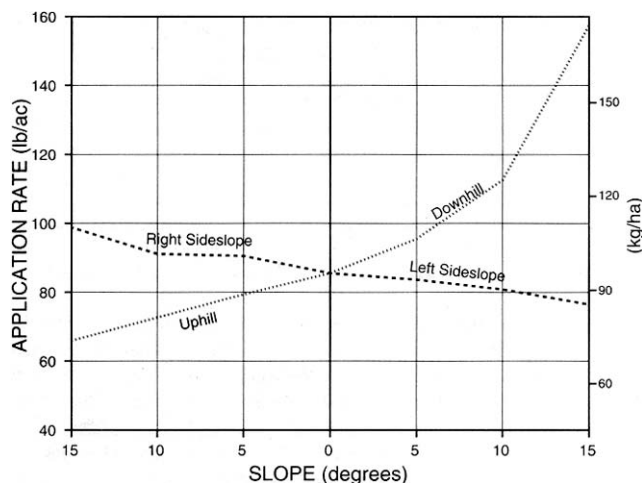
Level of material in the tank, field roughness and variations in fan and ground speed had no significant effect on the metering rates. Operating the Case IH 8500 on uphill, downhill and side slopes affected the metering rate of 11-51-0 fertilizer as shown in FIGURE 11. Travelling downhill on a 15 degree slope caused an 84 percent increase in the metering rate of 11-51-0 fertilizer. On a 15 degree downhill slope 11-51-0 fertilizer flowed by the meters. Travelling on a 15 degree uphill slope caused a 23 percent decrease in the metering rate of 11-51-0 fertilizer. Travelling on a 15 degree left side slope caused a 11 percent decrease and travelling on a 15 degree right side slope caused a 15 percent increase in the metering rate of 11-51-0 fertilizer. The AFMRC recommends the manufacturer modify the fertilizer metering system to eliminate the affect of slopes on rates.

FIGURE 11. Variation in 11-51-0 fertilizer application rate with change in field slope.

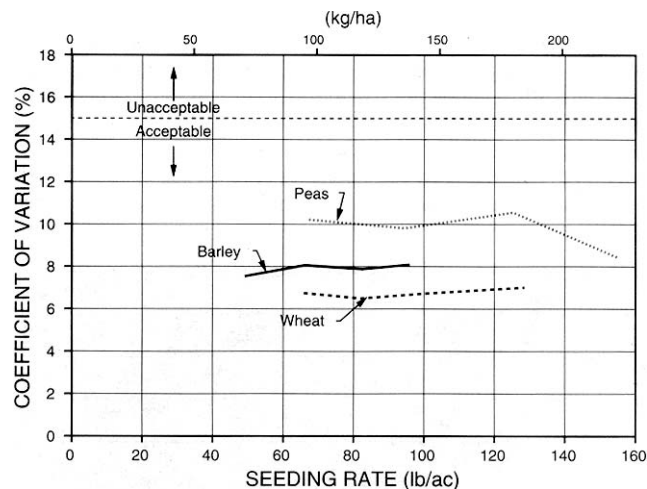
**Distribution Uniformity:** Uniformity of distribution of the application rates for the Case IH 8500 was good. FIGURES 12, 13 and 14 show the distribution uniformity with wheat, barley, Radley peas, 11-51-0 fertilizer and canola at various application rates.

Distribution was uniform with the coefficient of variation<sup>1</sup> (CV) ranging from 6.5 to 10.5 percent depending on the rate and material.

FIGURE 12. Distribution uniformity with wheat, barley and Radley peas over a range of seeding rates.

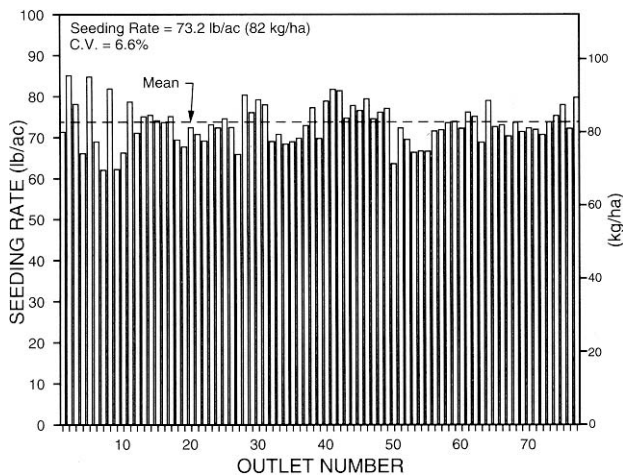
FIGURE 15 shows a typical seeding distribution uniformity pattern obtained with wheat at a seeding rate of 73 lb/ac (82 kg/ha). The seeding rate across the width of the unit varied from 62.1 to 85.1 lb/ac (69.6 to 95.4 kg/ha). This resulted in acceptable distribution uniformity with a CV of 6.6 percent.

FIGURE 15. Distribution uniformity pattern with wheat at 73.2 lb/ac (82 kg/ha).

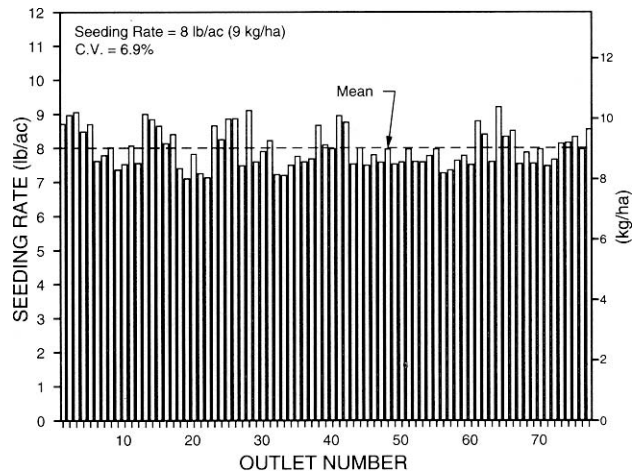
FIGURE 16 shows a typical seeding distribution uniformity pattern obtained with canola at a seeding rate of 8 lb/ac (9 kg/ha). The application rate across the width of the air drill varied from 7.1 to 9.2 lb/ac (8 to 10.3 kg/ha). This resulted in acceptable distribution uniformity with a CV of 6.9 percent.

FIGURE 16. Distribution pattern with canola at 8 lb/ac (9 kg/ha).

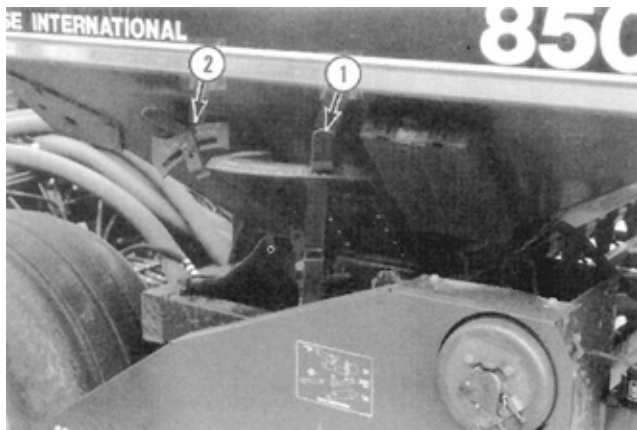
FIGURE 19. Application Rate Adjustment: (1) Seed and (2) Fertilizer.

**Application Rates:** Ease of setting the application rate for seed and fertilizer was very good. The seed rate was set by the adjustment lever (FIGURE 19), the shaft speed and the metering gates. For metering small seeds a slow shaft speed was obtained by switching two gears. The metering gates were adjustable to three positions.
